# DENSO DIGEST

Volume 38, Number 1

# Groundbreaking Advances in Offshore Pipelay: Denso's Viscotaq™ Offshore Field Joint Coating System

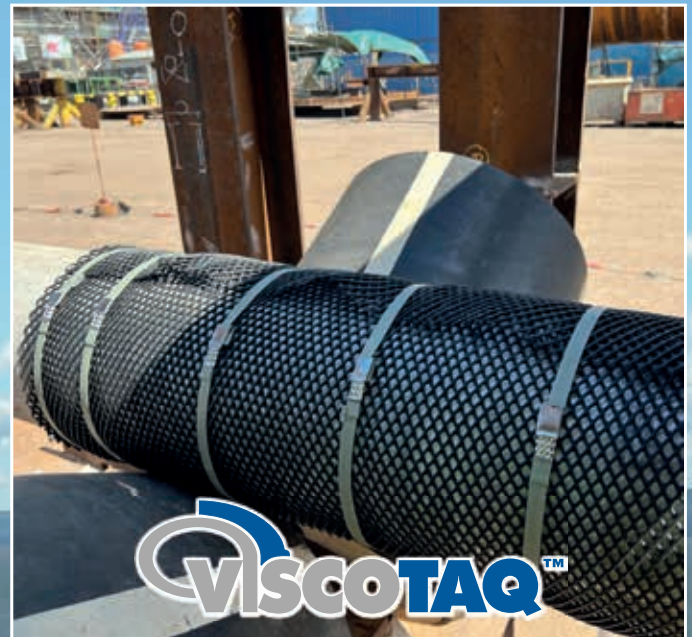
*Roller box test simulating the pipelay vessel's stringer operation.*

In addition to the PQT, the OIC required Roller Box Testing to be completed. The Viscotaq OFJC system was subjected to a 10-tonne load roller/stinger simulation. This testing was completed during the Pre-Production Test (PPT) stages at the OIC's yard. The Viscotaq OFJC system met all requirements of the Roller Box and PPT.

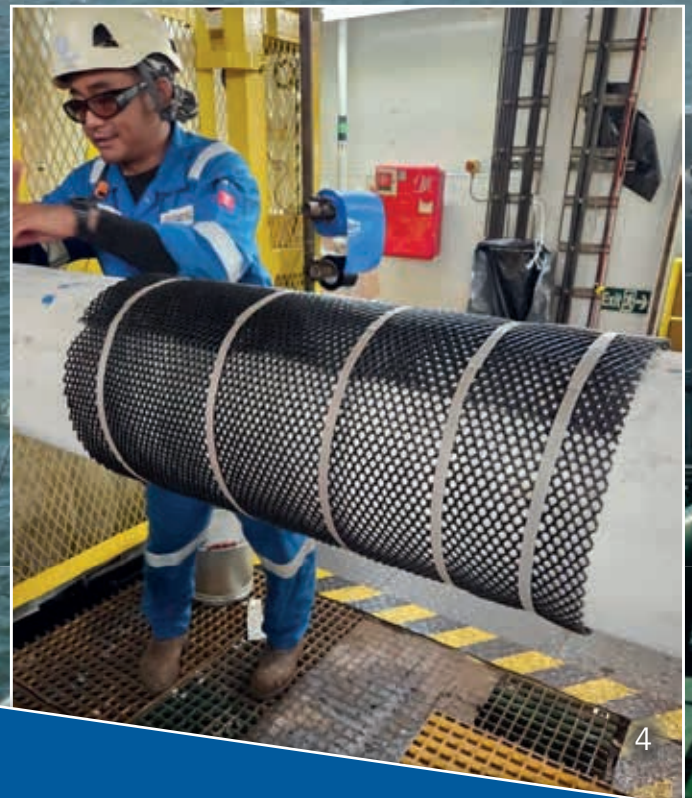
*A completed FJC application ready to be placed into the sea.*

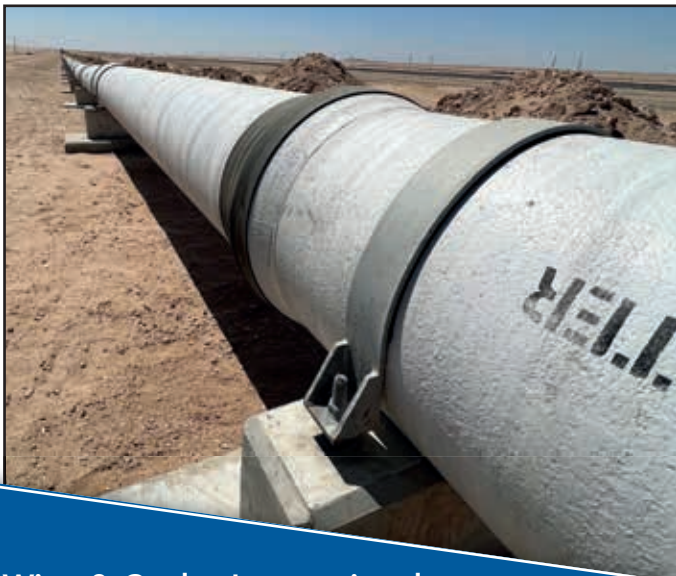
*Above ground pipe with threaded round bar and strapping securing pipe.*

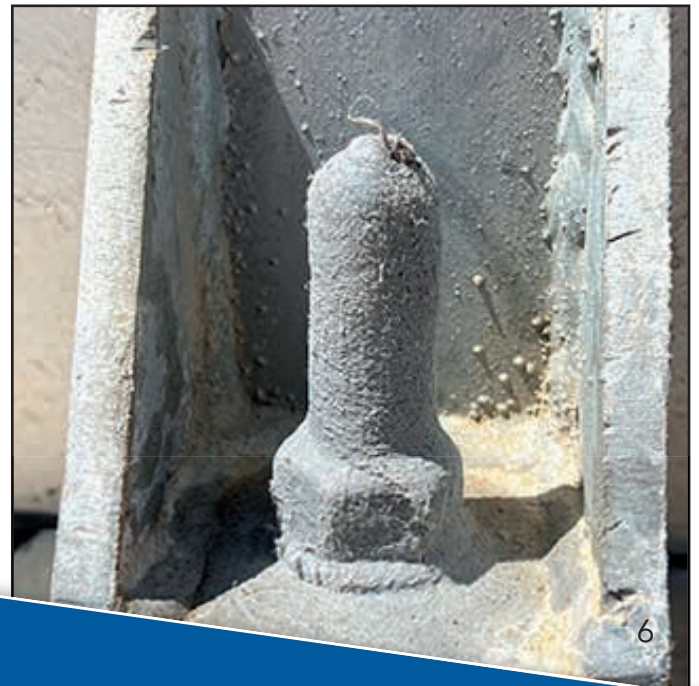
*Steelcoat™ ColourTape applied to M20 threaded rounded bars/nuts.*

Denso proposed and trialled the Steelcoat™ ColourTape in the presence of the client, consultant and contractor in October 2021 and, after three months of subjecting the ColourTape to the harsh environments of Namibia, it was removed from the threaded bars to reveal a corrosion-free bar.

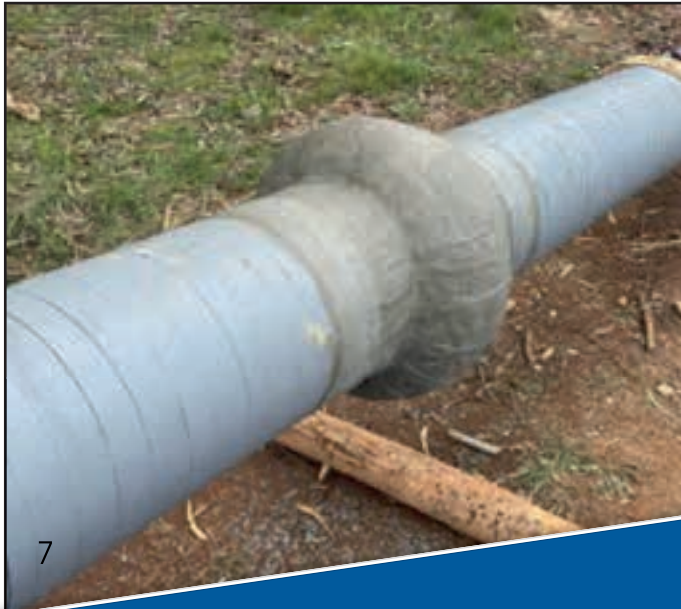
*The flanges were protected with the Denso™ Covercoat system before the application of the Denso™ Acrylic Topcoat to ensure UV stability.*

A combination of the Denso Steelcoat 500™ system, in conjunction with the Denso™ Covercoat system was used for the exposed pipeline and flanges. In addition Denso™ Glass Outerwrap was applied at the pipe brackets for mechanical protection.

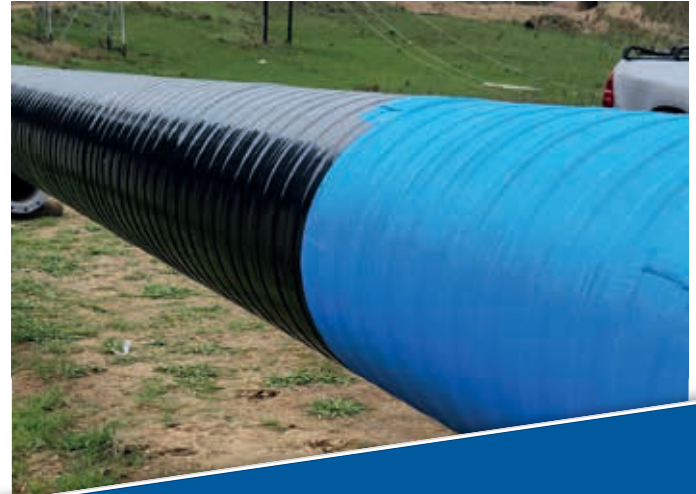
*Denso ViscoWrap™ ST and Denso™ PVC HD applied to a length of pipe as part of a trial section.*

The client also requested an on-site demonstration of Denso ViscoWrap™ ST and Denso™ PVC HD which was carried out on a 12m section of pipe.

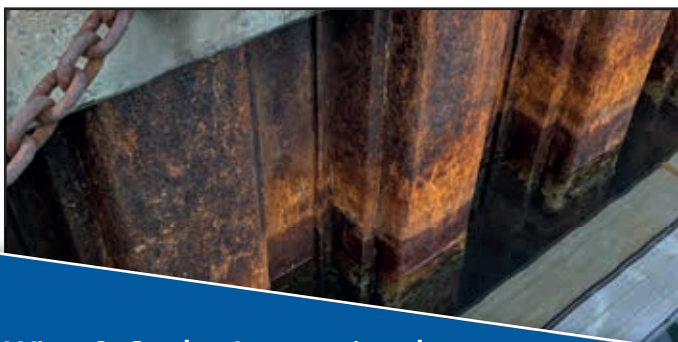
Below: Sheet pile wall before the SeaShield application.

The sheet pile wall on Rottnest Island was constructed in stages beginning in the 1960s and has suffered severe corrosion in the splash zone over that time. The \*SeaShield 2020SP™ System was selected to prevent further corrosion and provide a life extension to the structure.

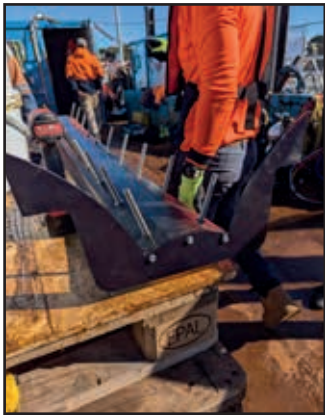
Wall attachment spine.

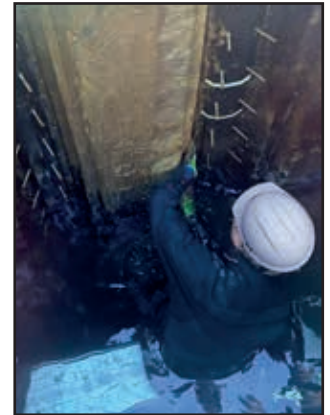
Application of Marine Piling Tape.

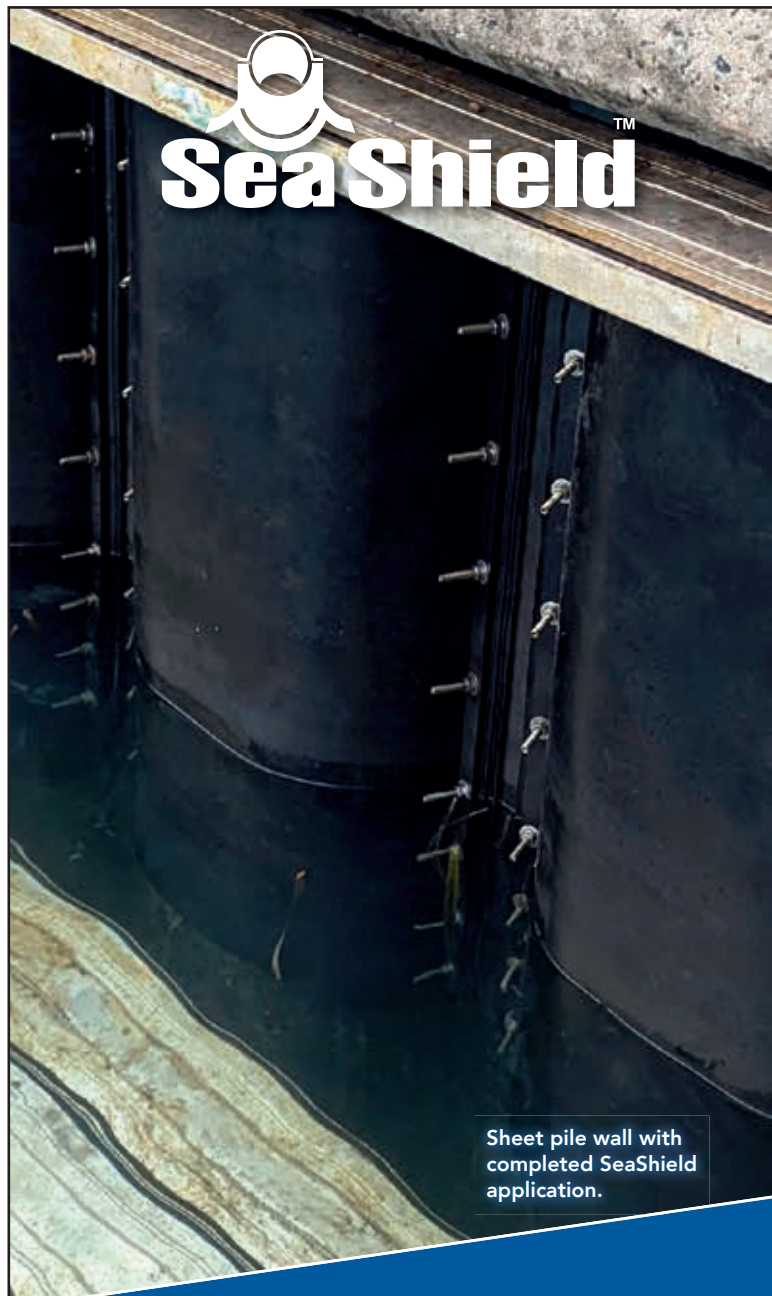
Sheet pile wall with completed SeaShield application.

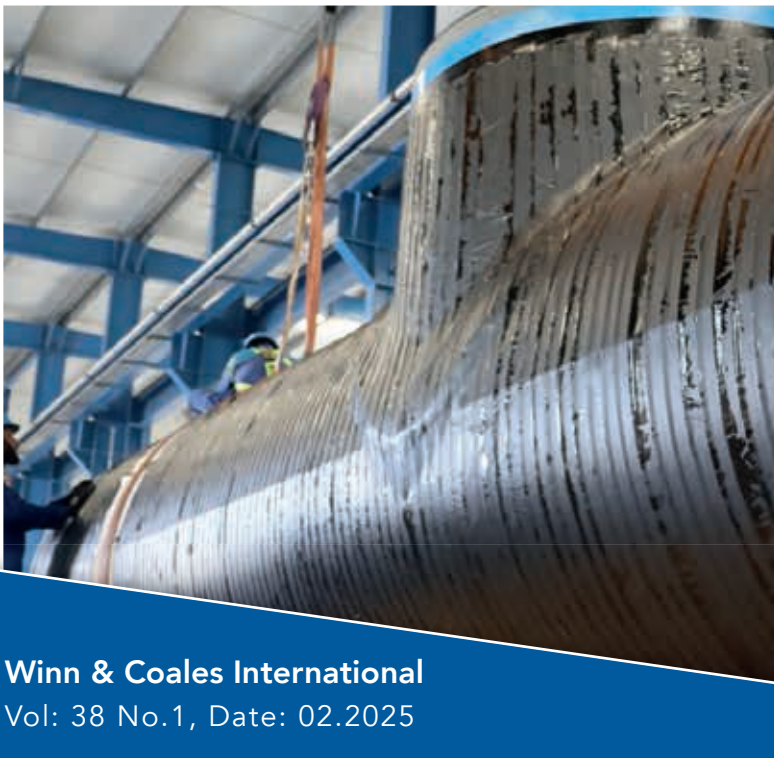
After priming with Denso Primer D, the initial wrap of Densopol 80HT is applied.

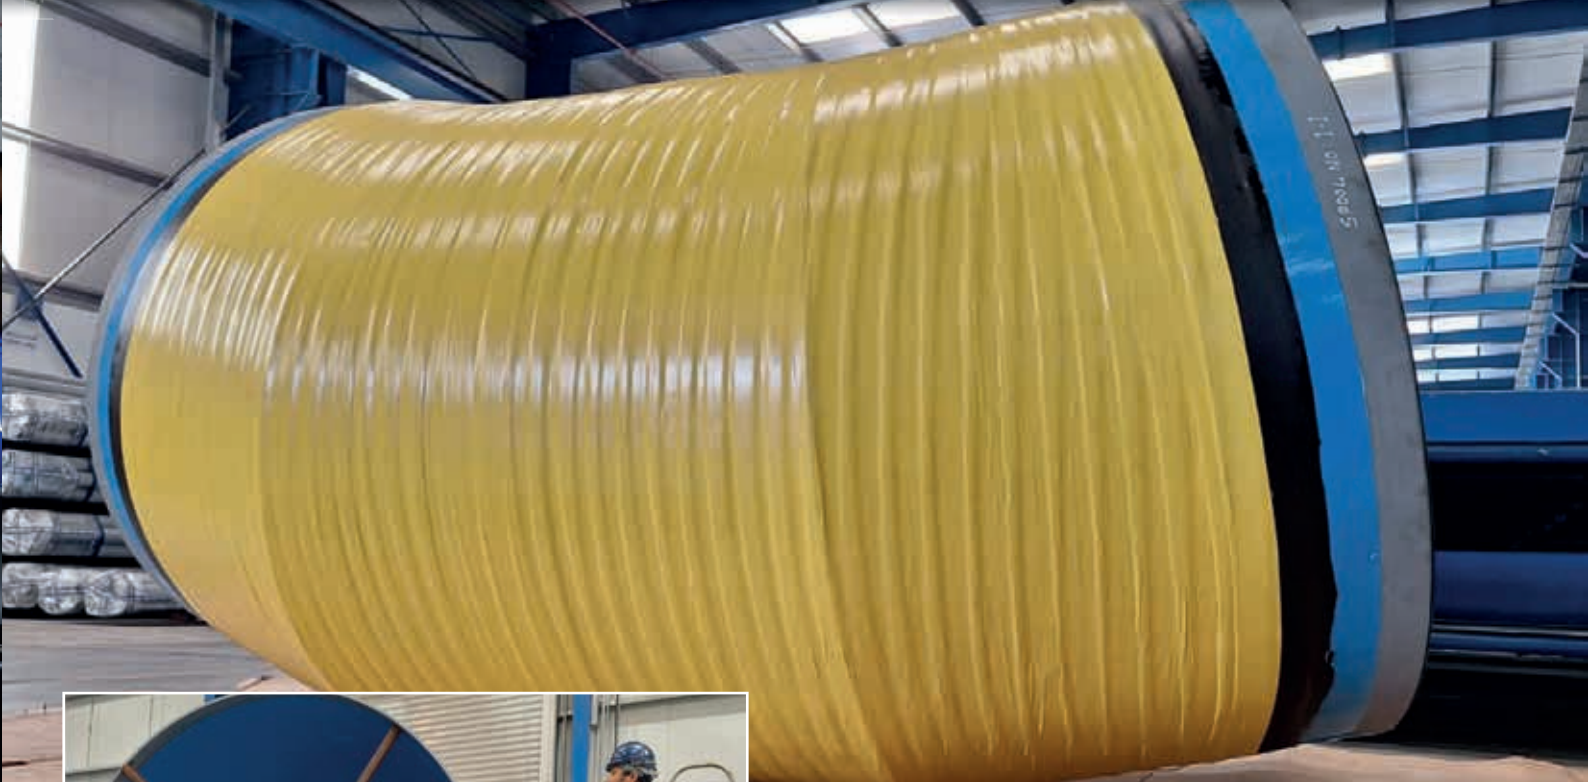
Above: A good example of a 50% overlapped tape wrap of Denso PVC SA 200 Tape, giving a double layer of outerwrap protection.

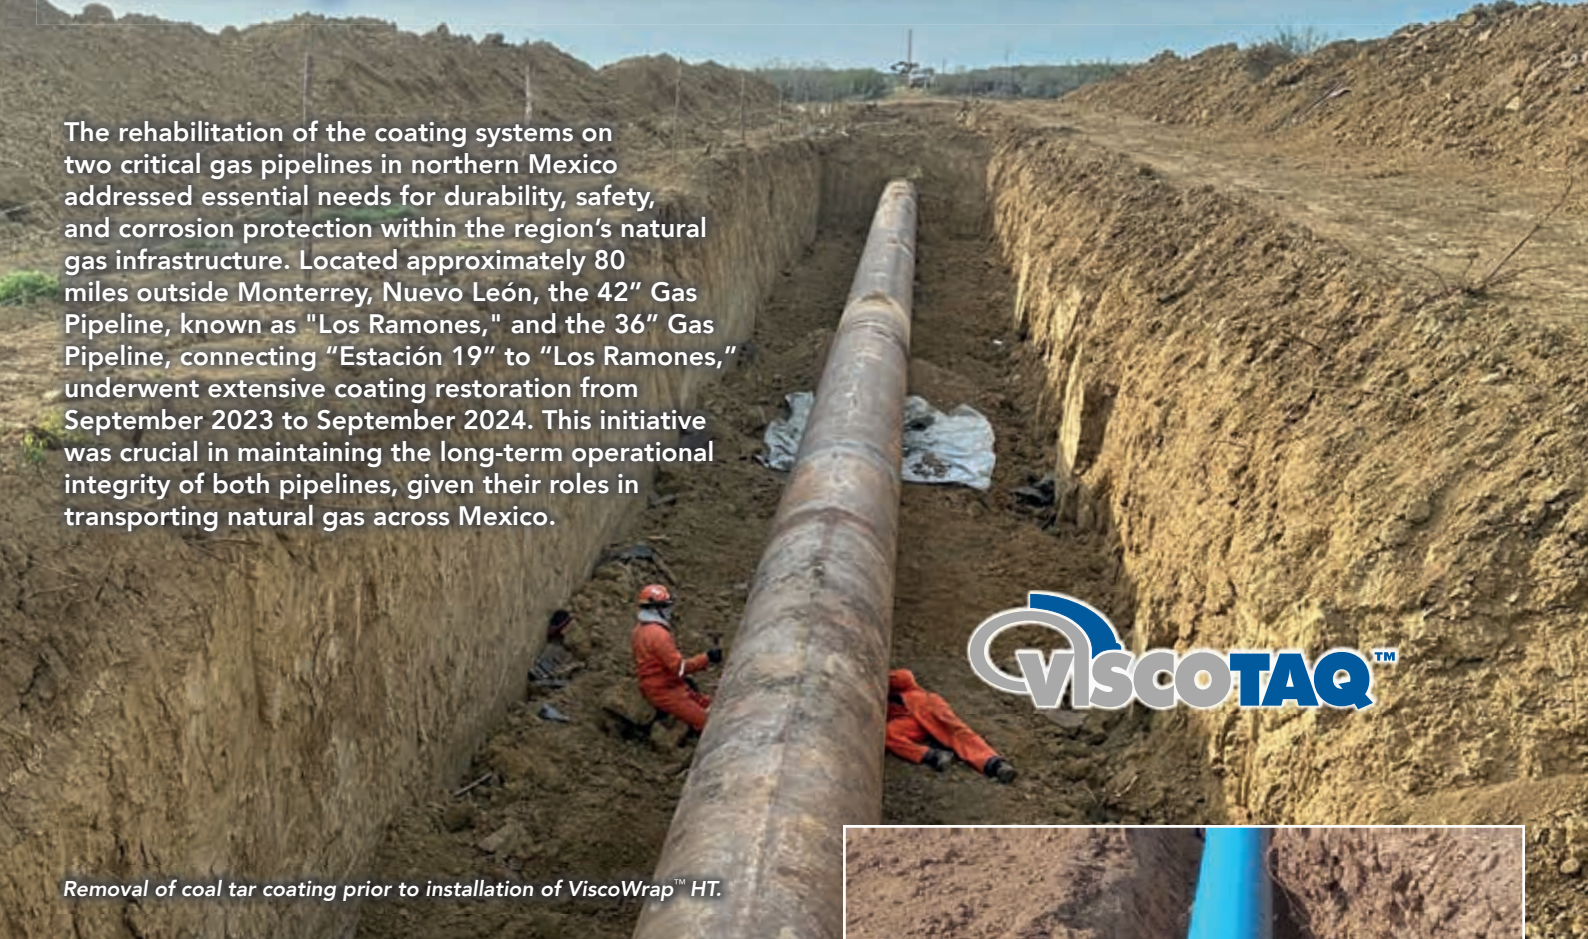
*Removal of coal tar coating prior to installation of ViscoWrap™ HT.*

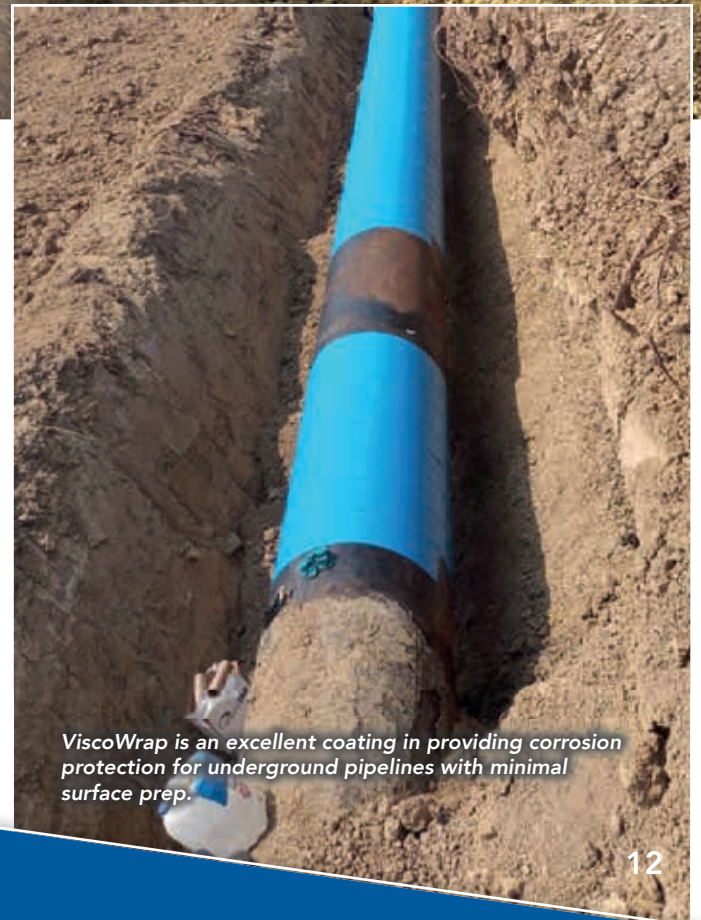
*ViscoWrap is an excellent coating in providing corrosion protection for underground pipelines with minimal surface prep.*

The rehabilitation work involved the application of advanced coating solutions designed to withstand Mexico's demanding environmental conditions. The coating system used included ViscoWrap™ HT (12" x 33') with an outer layer of Viscotaq™ Outerwrap PE (6" x 100'), a configuration selected for its robust corrosion protection capabilities. On suitably prepared surfaces the unique visco-elastic properties of ViscoWrap HT allow it to bond rapidly to substrates without priming, offering exceptional resilience against corrosion without the need for primer or abrasive blast cleaning to a high standard. Additionally, its self-healing nature makes it resistant to harsh soil conditions, ensuring the pipelines are better protected against potential damage and corrosion in the future. The result is a durable, low-maintenance solution that reduces operational costs while enhancing pipeline safety and longevity.

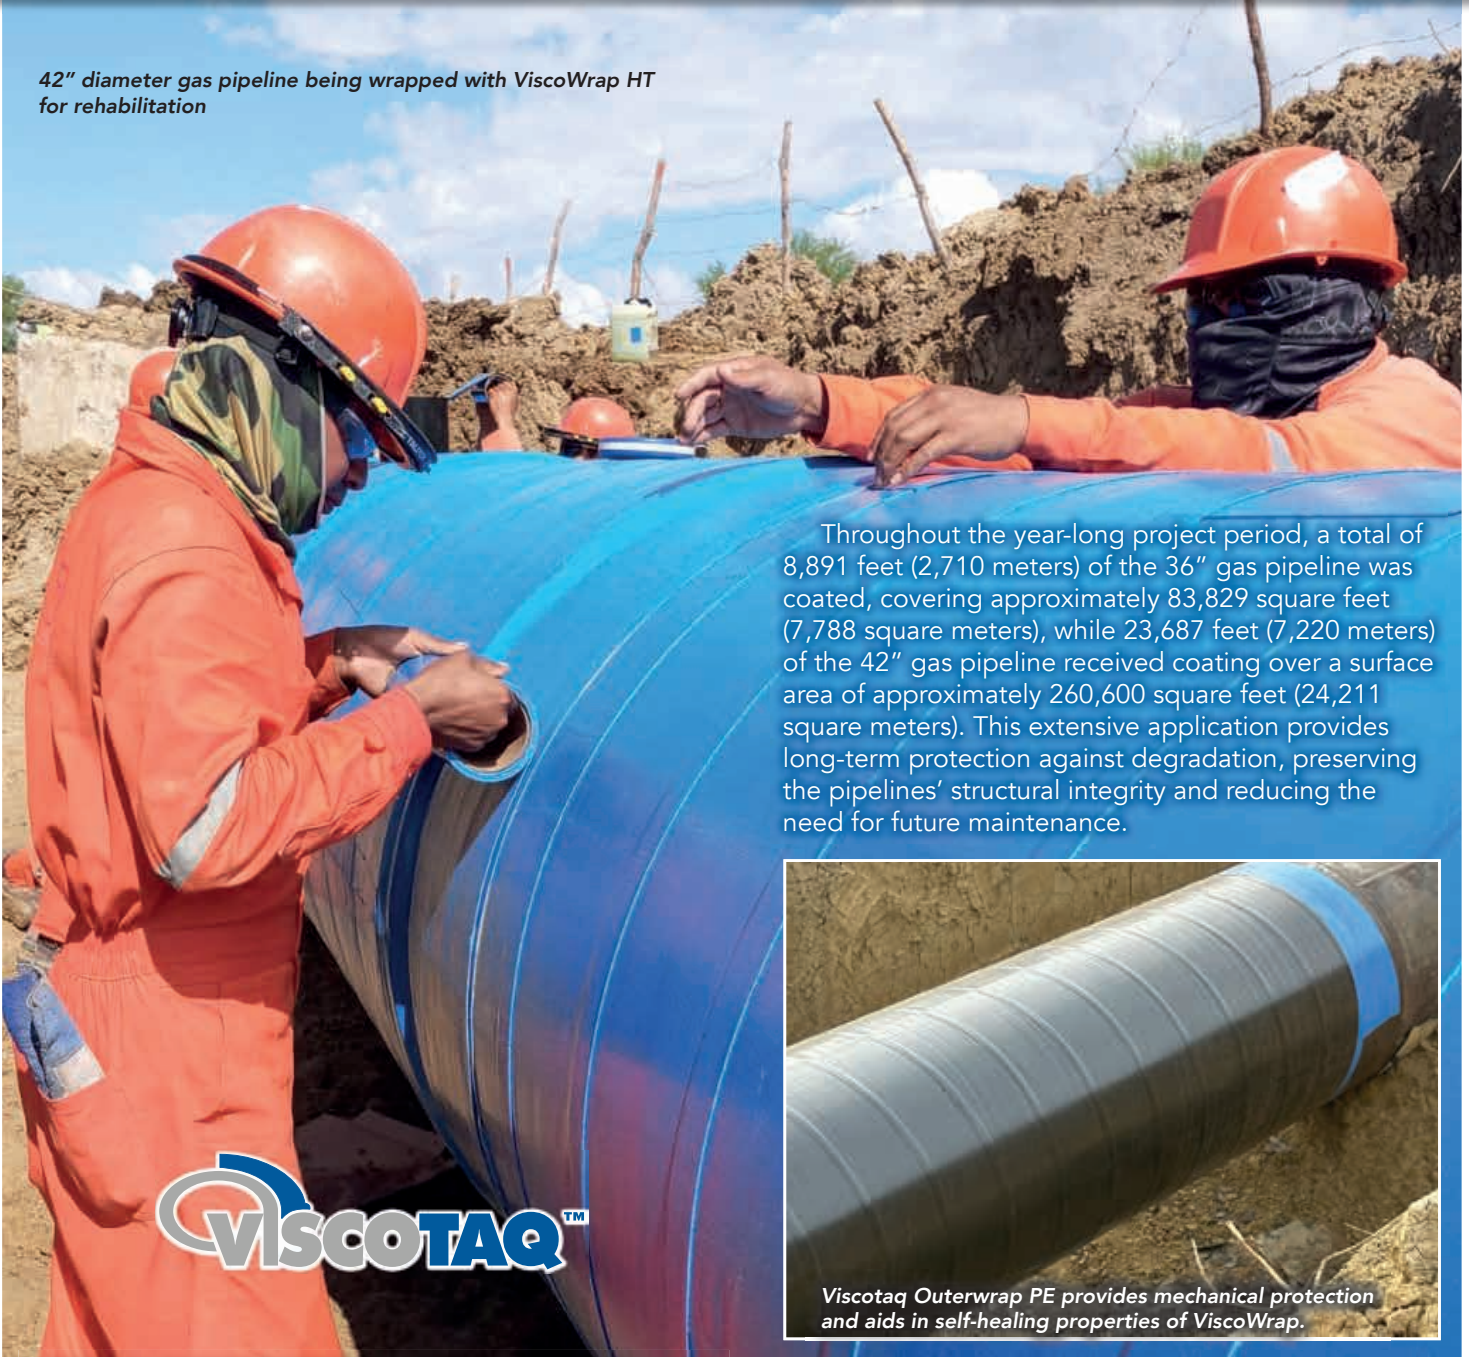
42" diameter gas pipeline being wrapped with ViscoWrap HT for rehabilitation

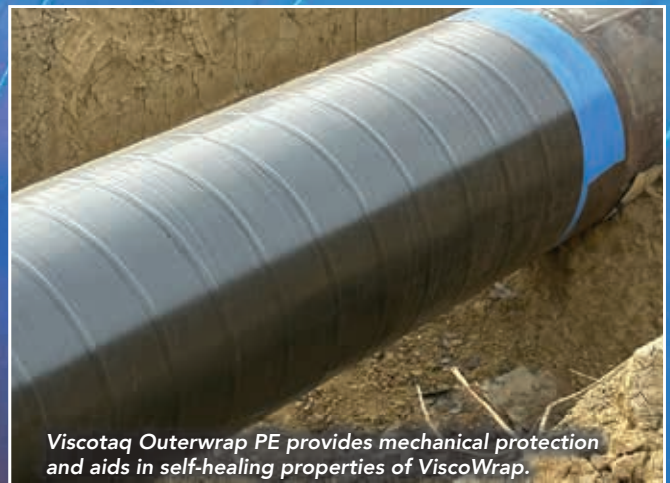
Viscotag Outerwrap PE provides mechanical protection and aids in self-healing properties of ViscoWrap.

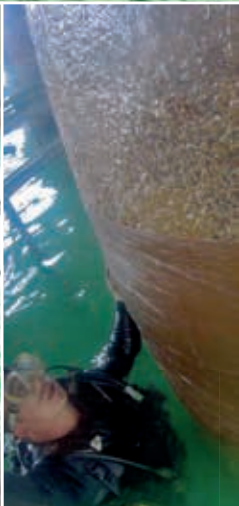
High pressure water jetting is used to prepare the surface before system application.
